Initial Seismic Study of Albany USD Schools and Facilities

**Prepared for
Albany Unified School District
Albany, CA**

February 24, 2012

**Prepared by
R. P. Gallagher Associates, Inc.
Structural Engineers
Oakland, CA**

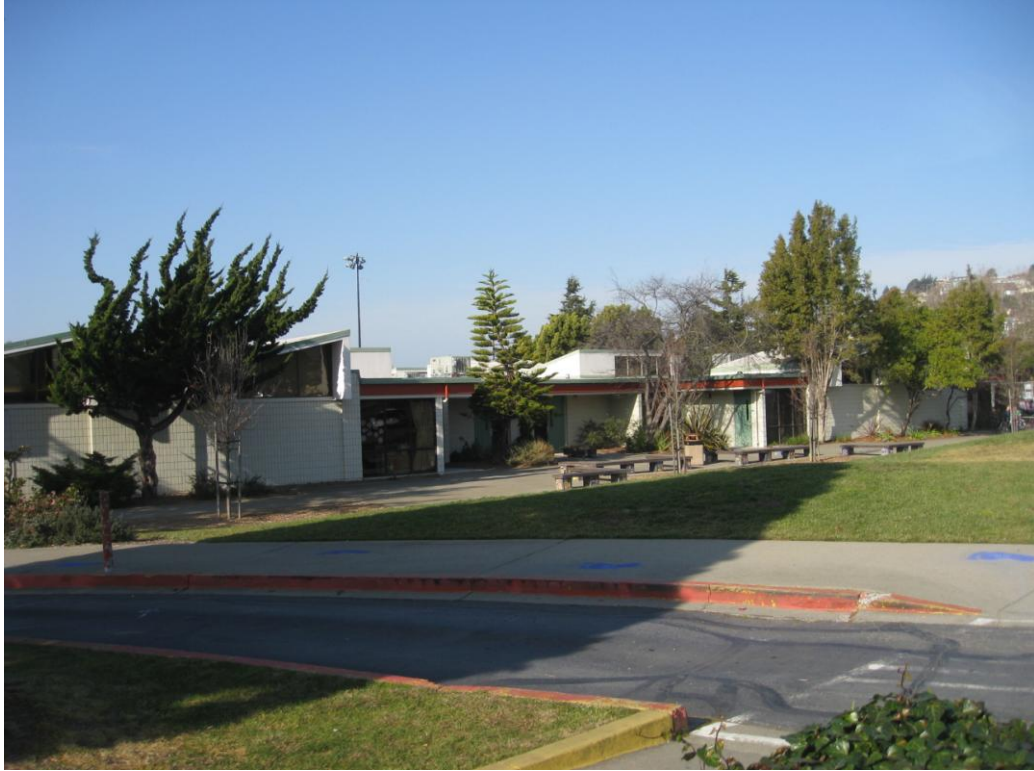
Figure 1 – Front of Ocean View Elementary School.

1. Ocean View Elementary School: The school is located on 1000 Jackson Street and Buchanan Street on a flat site. The study area of the 1997 University Village report was immediately adjacent to two sides of the Ocean View Site. Within the area of study, the report indicates subsidence due to liquefaction “is not expected to adversely affect foundation support of the residential structures.” Also, the report indicated “the potential for lateral spreading occurring at the site is very low.” Based on the results of the 1997 study and the proximity of the Ocean View site to the area of the study, the liquefaction risk is believed to be Low.
2. Marin Elementary School: The school is located at 1001 Santa Fe Avenue on a mostly flat site. The ABAG map indicates the risk at the site as Very Low.

- (4) Ocean View Elementary School. Originally this was the Albany Middle School campus. It was constructed in 1975. No buildings at this site were cited in the AB300 inventory list. However, based upon our review of the construction documents, the Classroom Buildings, the Library Wing, and the Multi-purpose Wing all have RM1 construction (Reinforced Masonry Walls with a Flexible Diaphragm). Therefore, these should be added to the AB300 list as Category 2 buildings requiring additional seismic investigation.

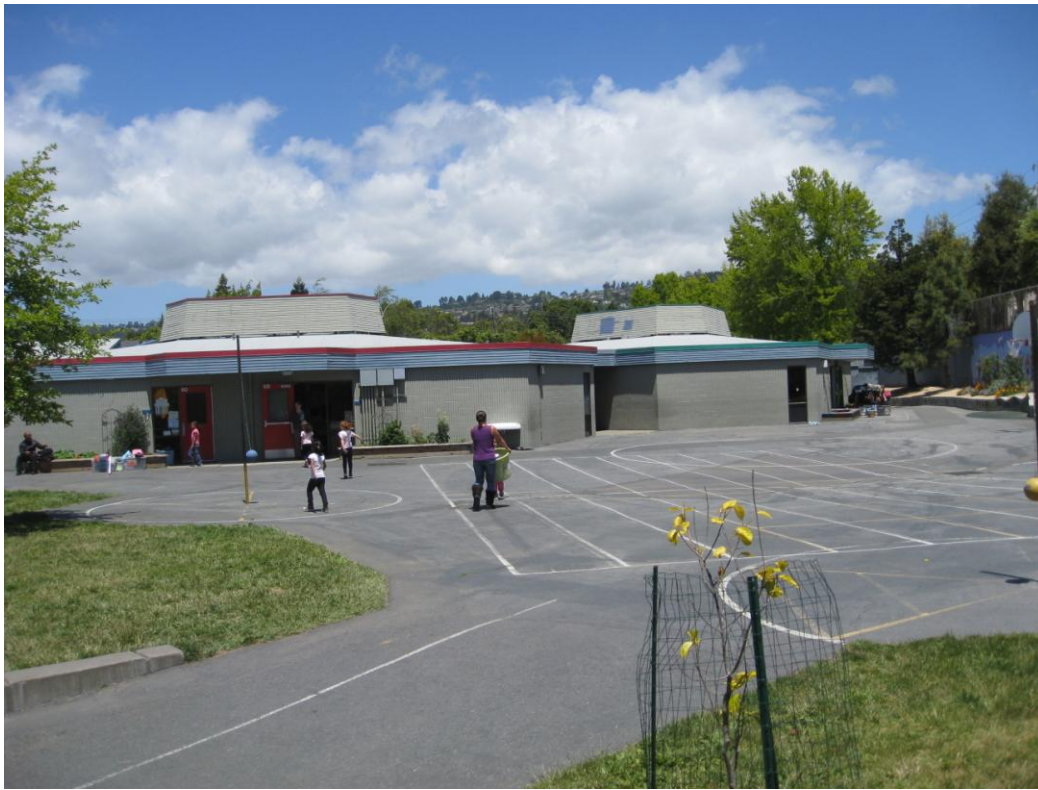
Figure 2 – Two buildings at Marin Elementary School.

- (3) Marin Elementary School. Two buildings at this site were identified as having construction type RM1 (Reinforced Masonry Walls with a Flexible Diaphragm), which is deemed Category 2. We agree with the building classification. However, based upon our review of the construction documents and a site visit, a total of seven buildings of this construction type (RM1) are on the site. Therefore, five additional buildings should be added to the list of Category 2 buildings for this site.

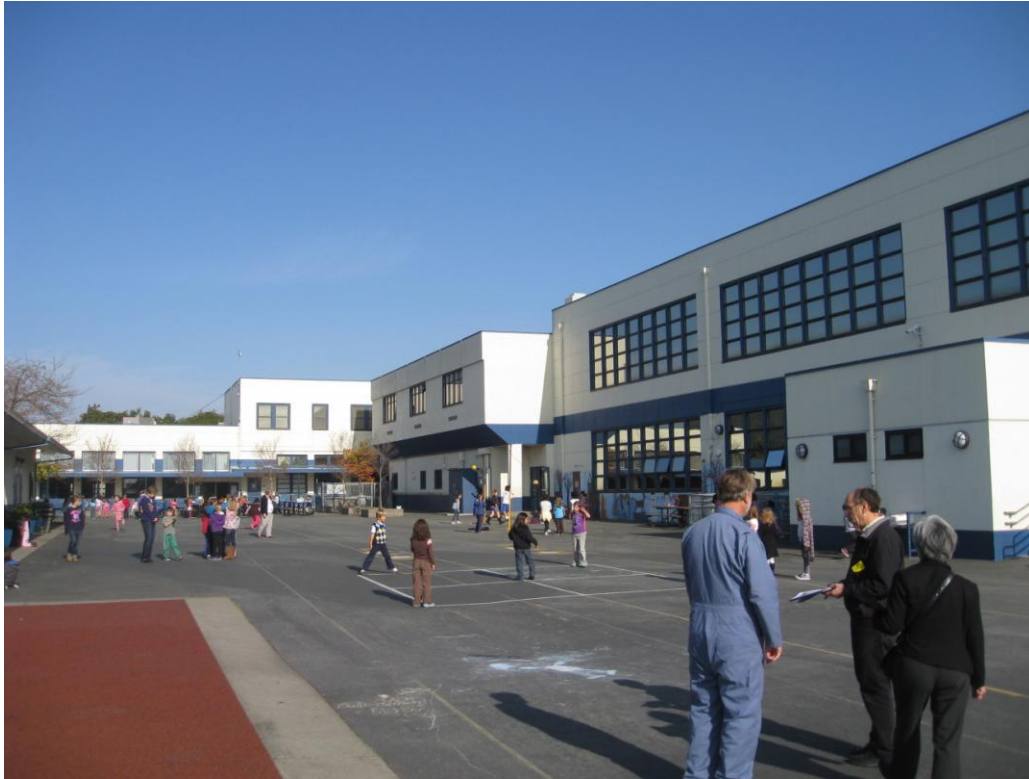
Figure 3 – West side of Cornell Elementary School.

3. Cornell Elementary School: Located at 920 Talbot Avenue and Solano Avenue, Cornell school is on a flat site. The ABAG map indicates the liquefaction risk as Low.

- (5) Two of the original buildings at Cornell Elementary School, the North and South Wings, have a Category 2 construction type (C2A – Concrete Shear Wall with Flexible Diaphragm). However, these have undergone a recent structural/seismic improvement (see Table 2) and are no longer considered Category 2. The South Wing is indicated as being upgraded to the 1995 CBC (Ref. 10) and the North Wing to the 1998 CBC (Ref. 11).

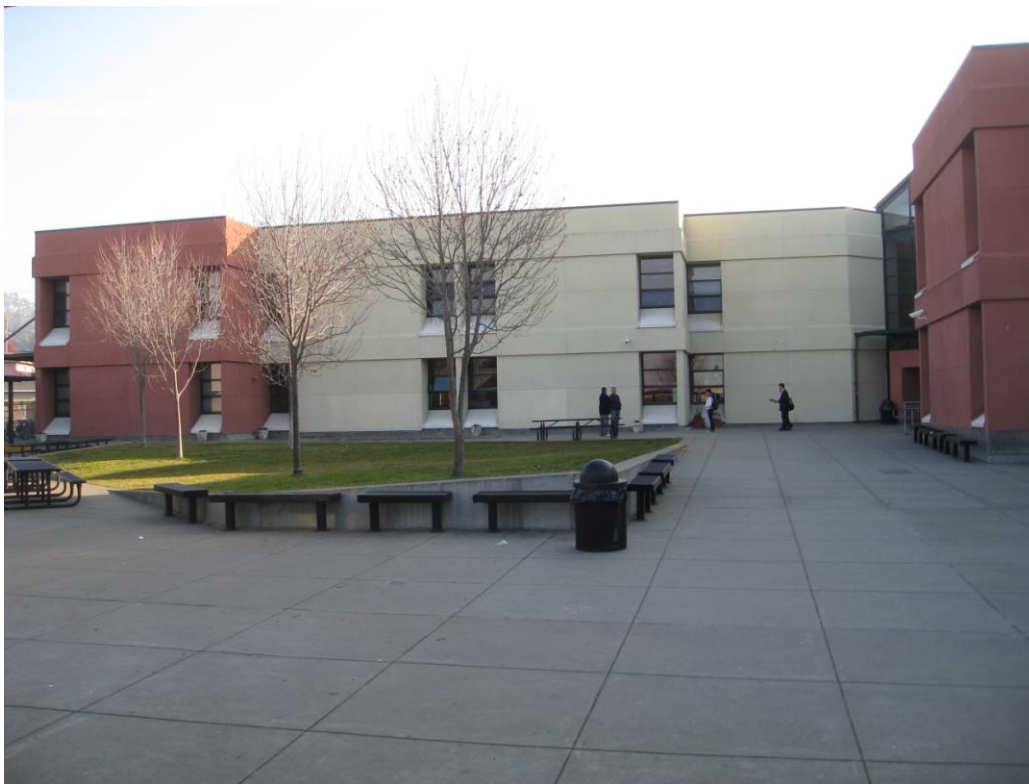
Figure 4 – Buildings at Albany Middle School.

4. Albany Middle School: Albany Middle School is located at 1259 Brighton Avenue on a flat, slightly sloping site. The ABAG map indicates Low liquefaction susceptibility. However, because the school was built in the late 1990s, the site was found acceptable for new school buildings by the California Geological Survey. Therefore, no significant liquefaction hazard would be present.

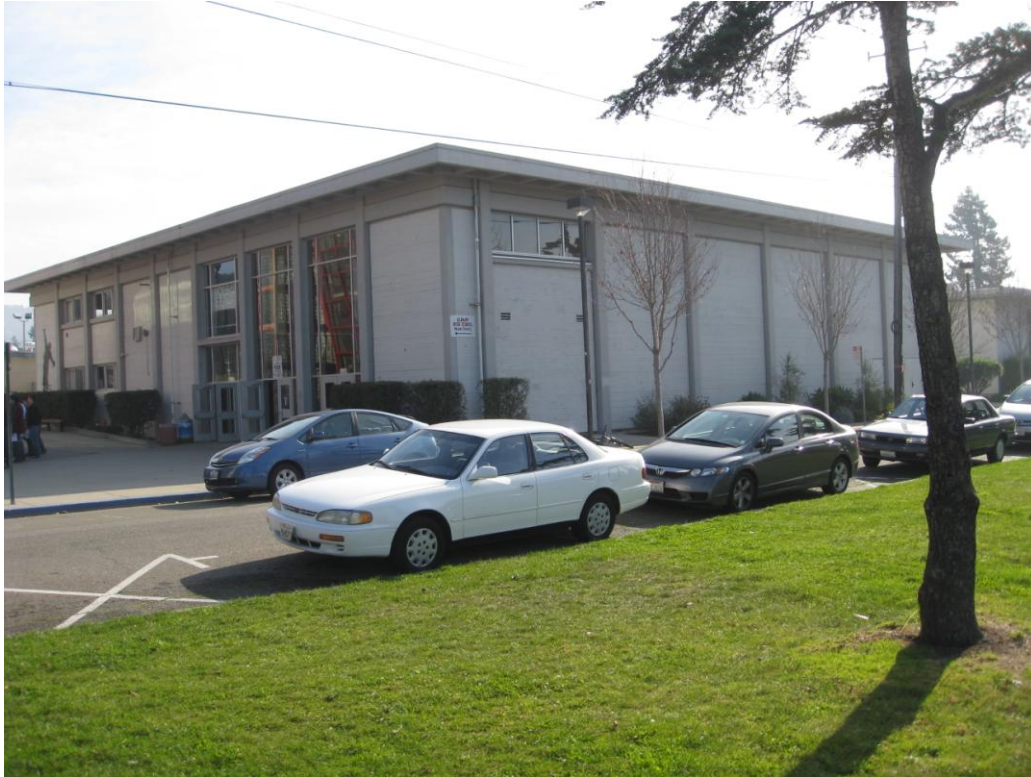
Figure 5 - Little Theater building at Albany High School.

- (1) Albany High School “Little Theatre”. This is also called the Fine Arts Building. This was determined by visual observation to be building classification type to be C2 (Concrete Shear Walls with Rigid Diaphragm). According to Table 2 of the AB300 report (see Appendix A), building classification type C2 is a Category 1 building and not Category 2. This determination was made by field inspection by two structural engineers from our office. The original structural drawings for the building have not been found.

- (3) While we believe the Little Theater at the High School has type C2 construction and is therefore Category 1, the structural drawings for this building should be obtained and reviewed to confirm this.

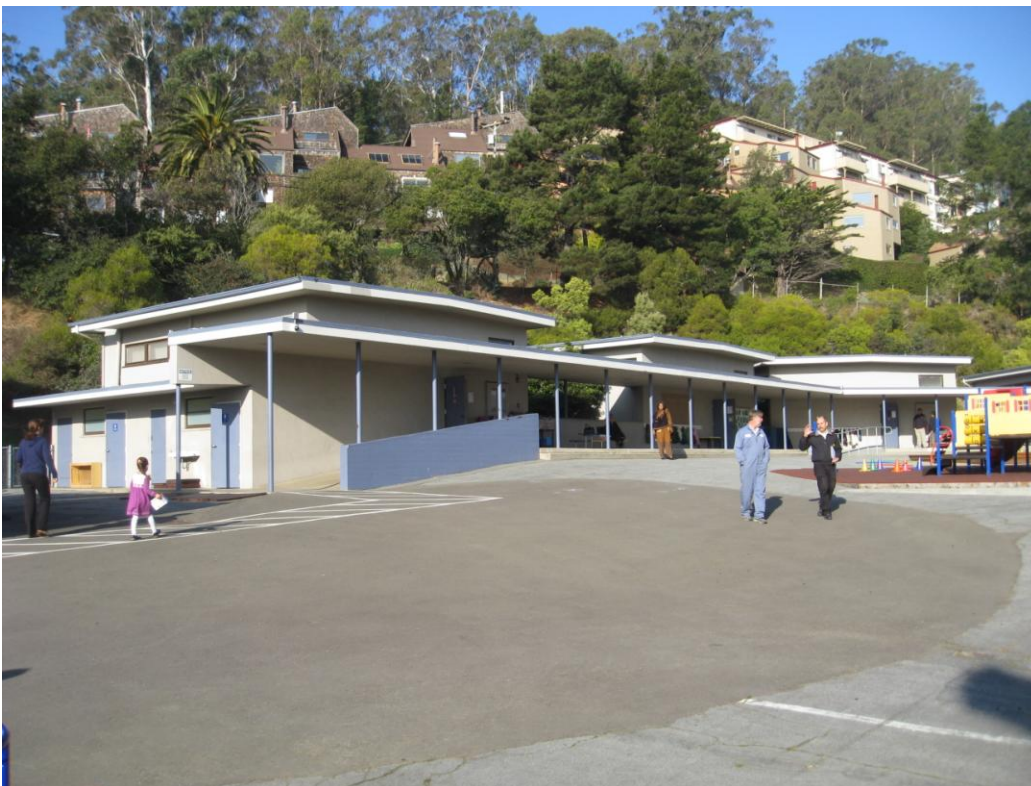
Figure 6 – Three classrooms at the Albany Children's Center.

6. Albany Children's Center: The Children's Center is located at 720 Jackson Street on the lower slopes of Albany Hill. The site is sloped. Not unexpectedly because the Center is located at the base of a hill, the ABAG map indicates the liquefaction risk as Very Low. We examined the site, and there are some relatively steep slopes behind the Center. While we saw no evidence of any past slope movement, it is not known if the site would experience any slope failure or landsliding during a large earthquake on the Hayward fault.

The Albany sites appear to be generally free of significant site hazards with one possible exception. The Albany Children's Center site has a relatively steep slope at the back of the school, and this should be examined by a geologist or geotechnical engineer for slope stability during a major earthquake.

- (2) The slope behind the Albany Children's Center should be examined by a licensed geologist or geotechnical engineer to evaluate the stability of the slope in a major earthquake.

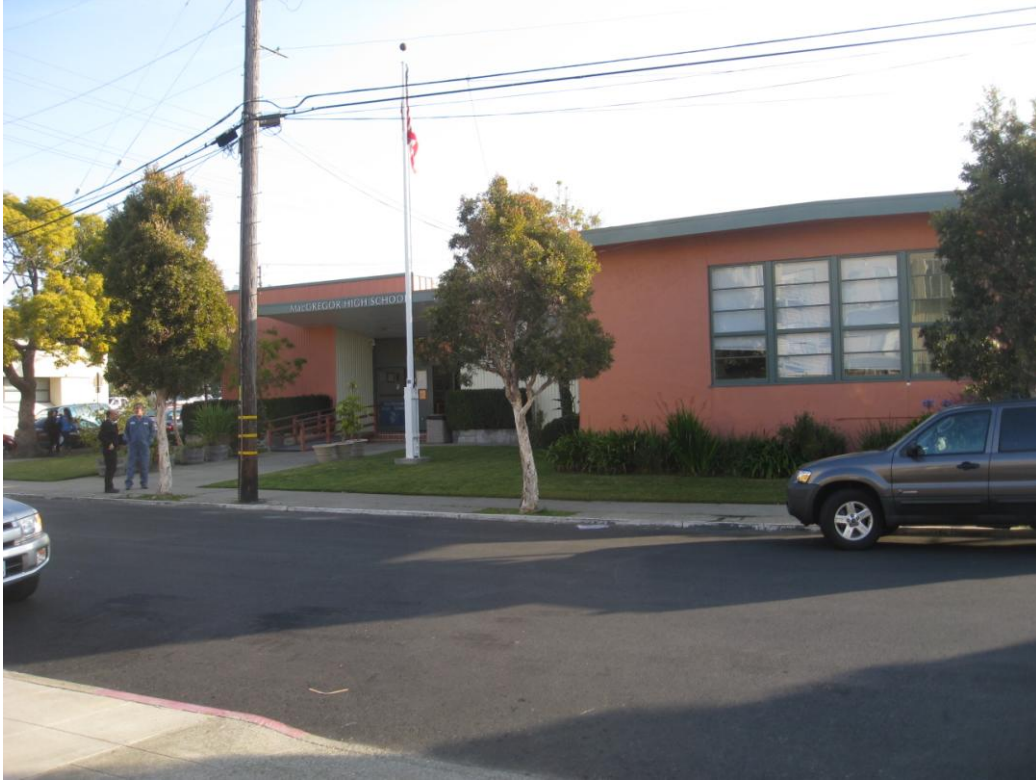
Figure 7 – MacGregor High School.

7. MacGregor High School: Located at 601 San Gabriel Avenue, the site is across the street from Albany Middle School. The ABAG map indicates the liquefaction risk as Low.

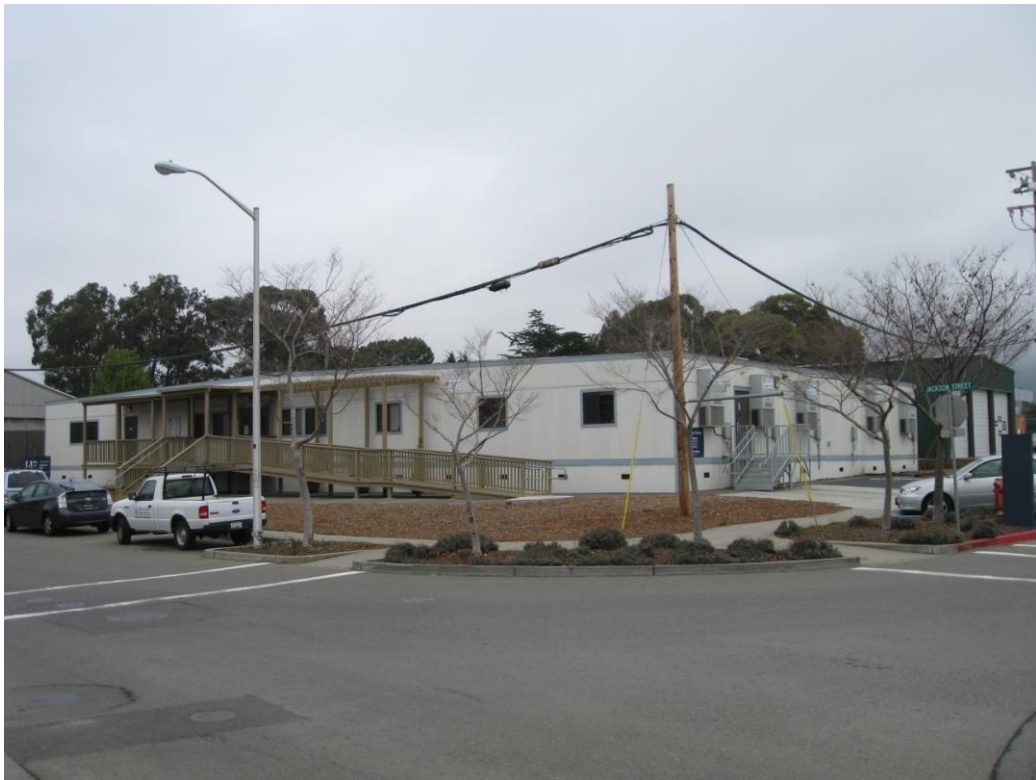
Figure 8 – District Office.

8. District Office: Located at 1051 Monroe Street, the District Office is in modular buildings on a flat site. The area investigated for the 1997 University Village geotechnical report included the site, and the liquefaction risk is considered Low.

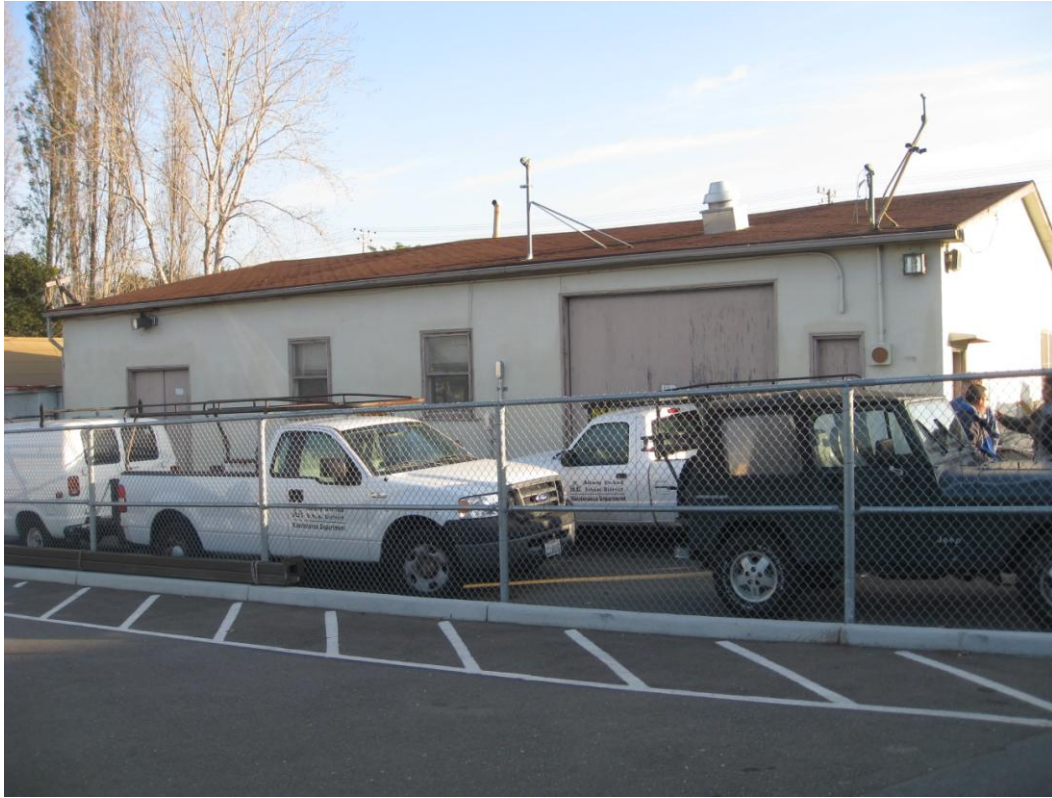
Figure 9 – Maintenance Facility building.

9. Maintenance Facility: This is adjacent the Albany Middle School. The site is flat, and because of the facility's proximity to a new DSA-certified school, no significant geologic site hazards are believed to exist.

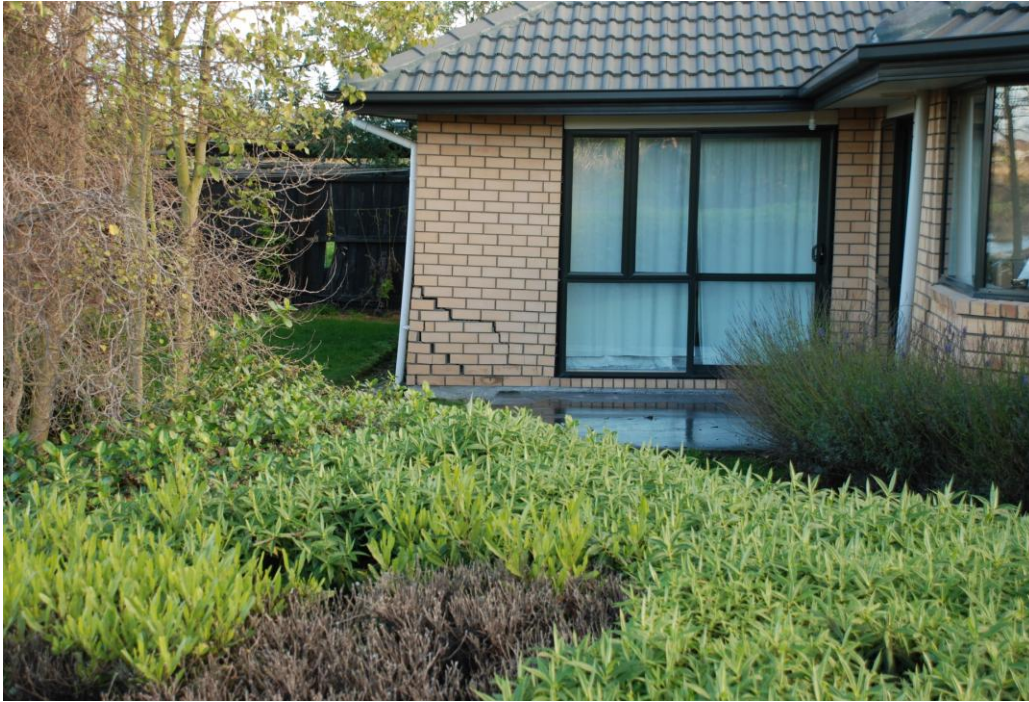
Figure 10 – Example of liquefaction damage to a house after the magnitude 6.3 February 22, 2011 Christchurch, New Zealand earthquake. The house was undamaged by shaking but seriously damaged by ground movements caused by liquefaction.

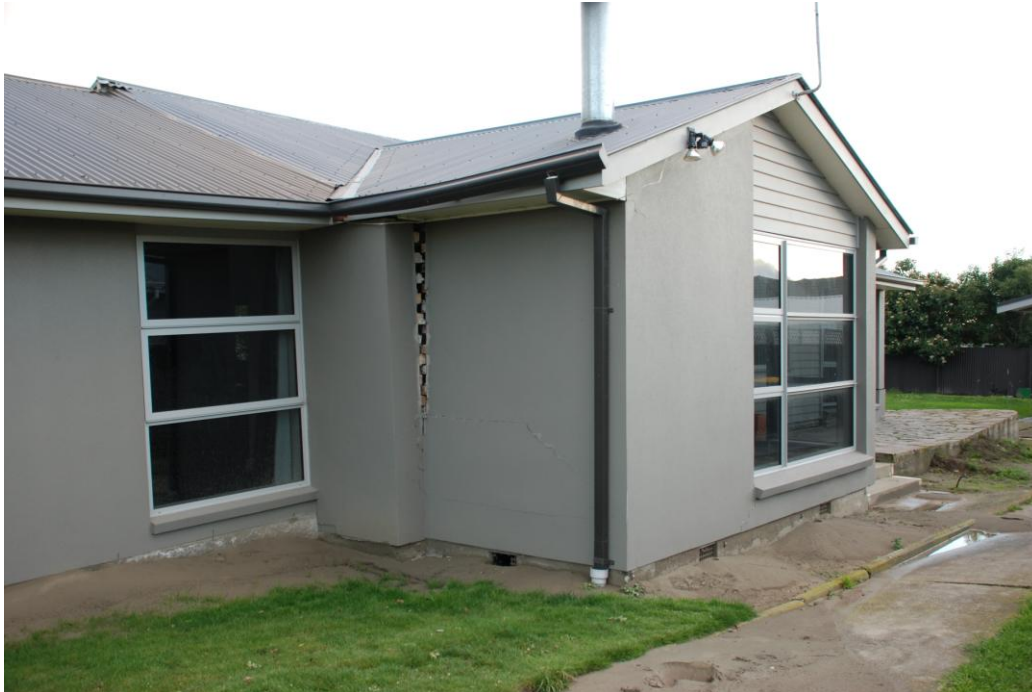
Figure 11 – A “tear” in the walls of a house caused by liquefaction-induced ground settlements. This happened when liquefaction caused the house to settle unevenly. Houses in this area will be abandoned. Repair or rebuilding was not feasible.

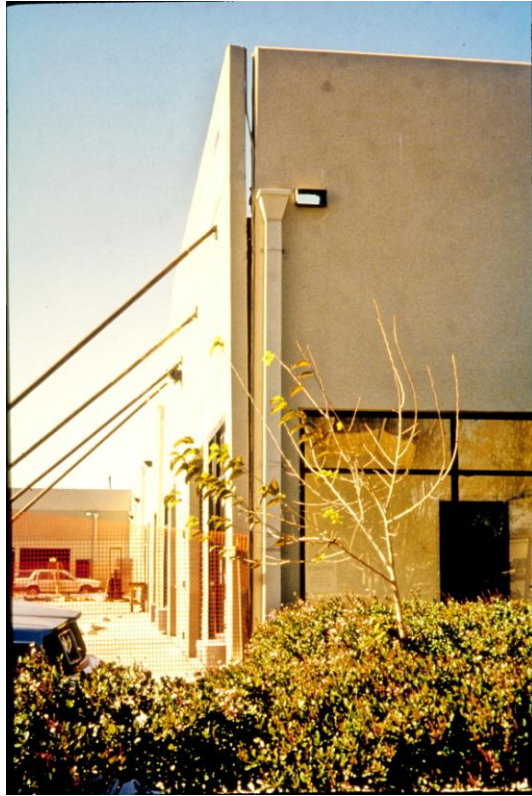
Figures 12 and 13 illustrate wall-roof separations caused by the 1994 Northridge earthquake. What is shown are relatively "moderate" forms of wall-roof separation. In the more life-threatening forms, roofs have collapsed and walls have fallen over.

Figure 12 – An example of wall separation from the roof of a building. When this happens, the walls can fall over, the roof can collapse locally, or both can happen.

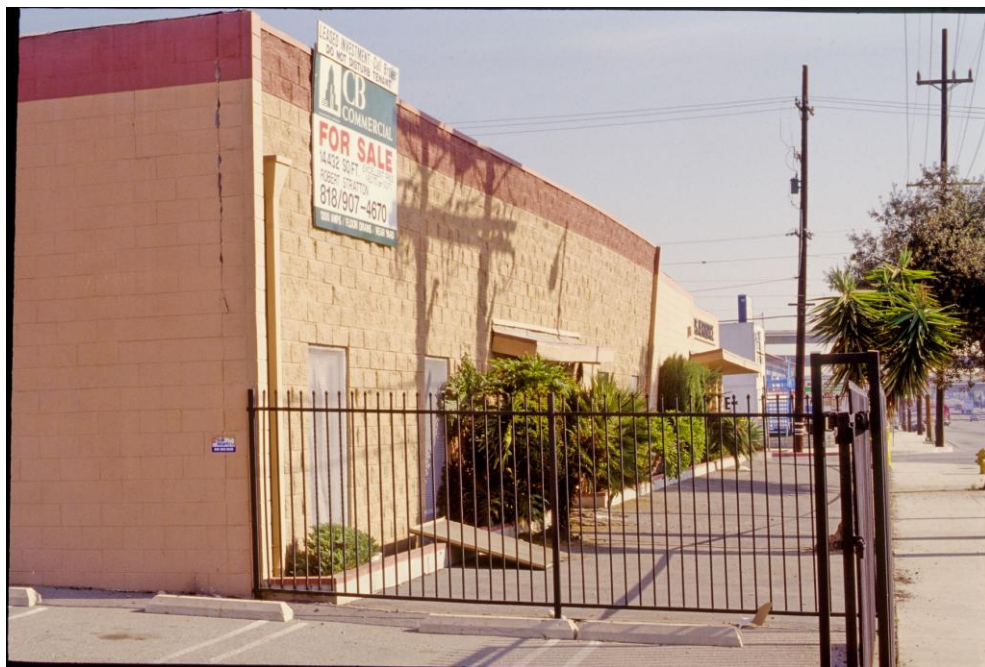
Figure 13 – The masonry wall at the right front of this building has pulled away from the roof. This can be a serious problem in buildings with concrete block or tilt-up concrete walls that have wood roofs.
