NEEDS ASSESSMENT STUDY:
ALBANY HIGH SCHOOL
SWIMMING POOL

15 AUGUST 2007

Aquatic Design Group, Inc.
1950 Kellogg Avenue
Carlsbad, CA 92008
760.438.8400
www.aquaticdesigngroup.com

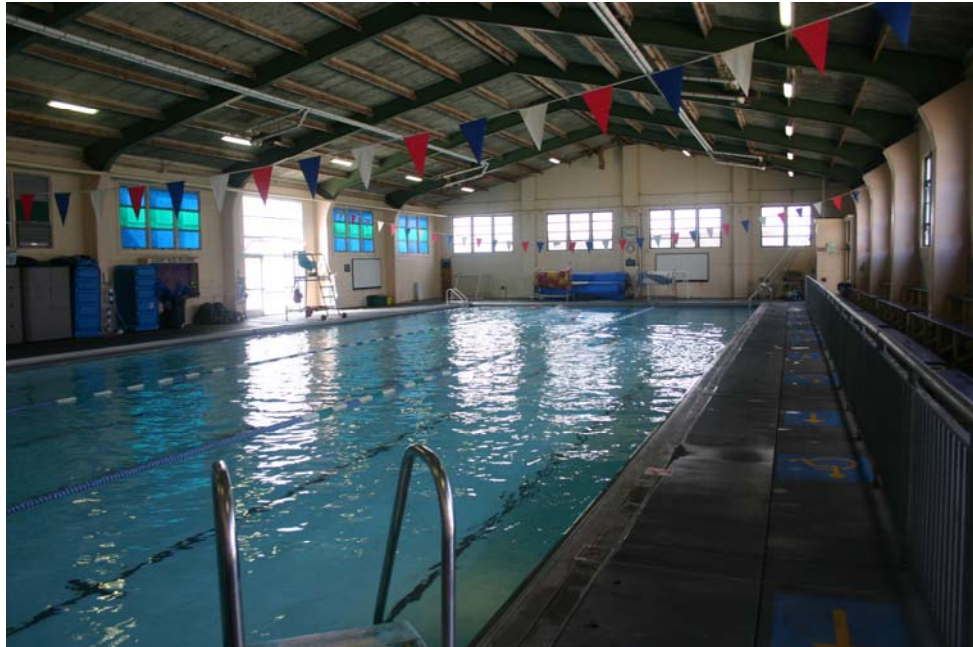
- 1.1 The pool decking is cracked in numerous places. The deck does not have proper drainage. It has areas of standing water behind the pool gutter and elsewhere where pathogens can grow and creating slip trip and fall hazards in violation of Title 24, Chapter 31B:

Exhibit 10: Pool Deck Standing Water

All decking should be replaced with a medium broom finish concrete, directed to approved drainage devices. Cost includes demo of existing deck, new broom finish concrete decks, and new deck anchors. The required deck safety markings and deck drainage that are missing at the existing pool should be added at this time.

(Estimated Cost: \$310,000.00)

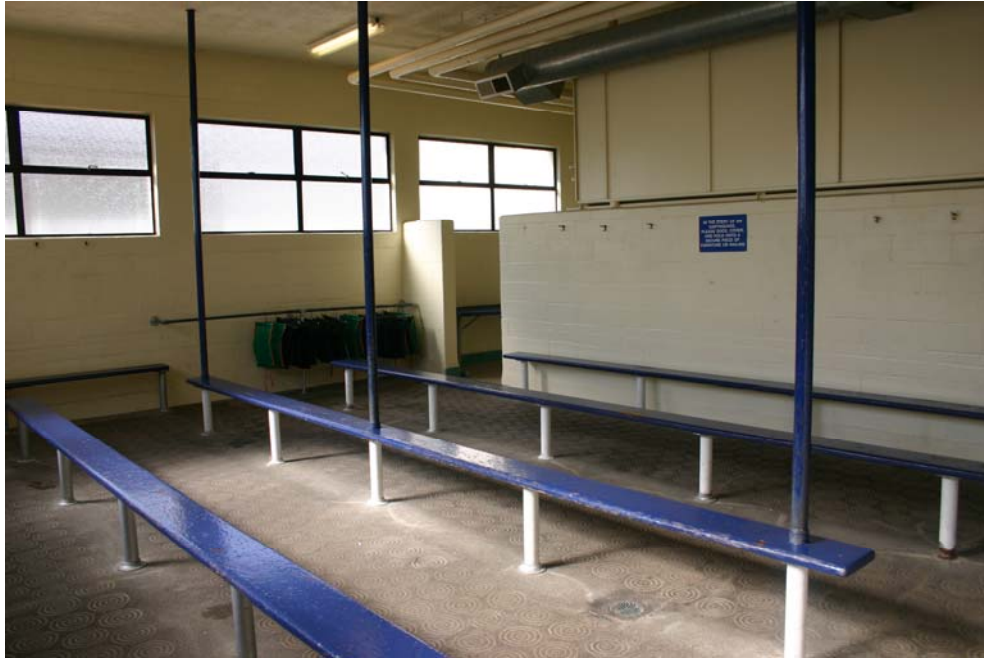
- I.5 The pool locker rooms and toilet facilities do not provide ADA accessibility. The floor to wall transition lacks a coving. Portions of the flooring is reported by the staff to have a slip trip and fall condition. All of these conditions are in violation of Title 24, Chapter 31B:

Existing Changing Area

The following is an estimate to fully renovate the changing room and toilet room facilities. It assumes that the toilet fixtures are relocated to provide ADA accessibility and the floor and wall finishes renovated to comply with code. The following estimate assumes a renovation cost of \$175 per square foot for such a renovation.

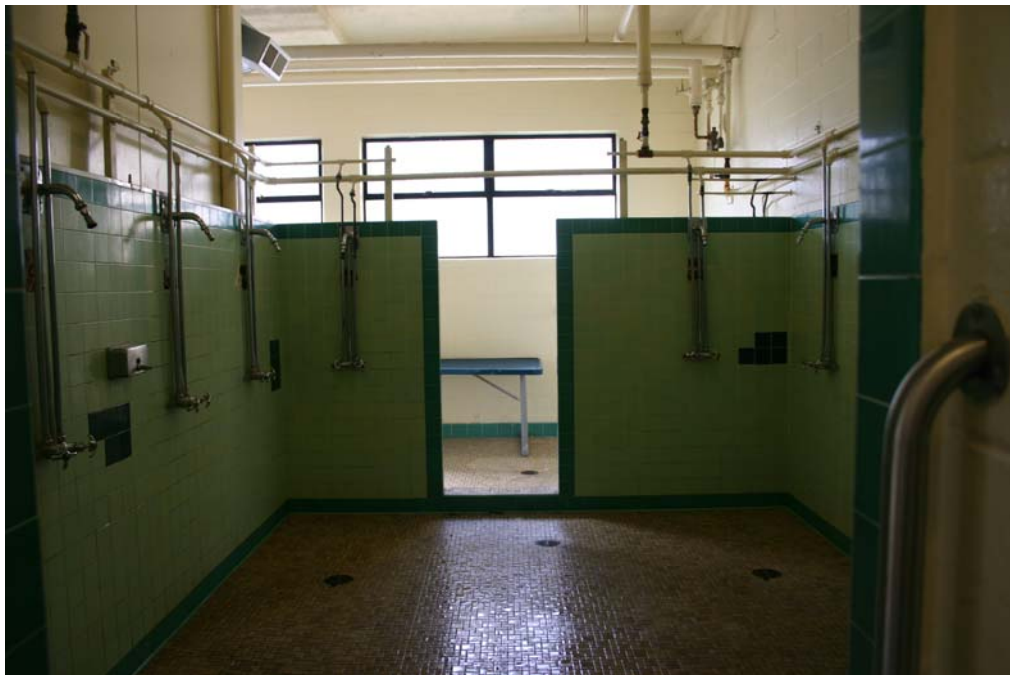
Existing Showers

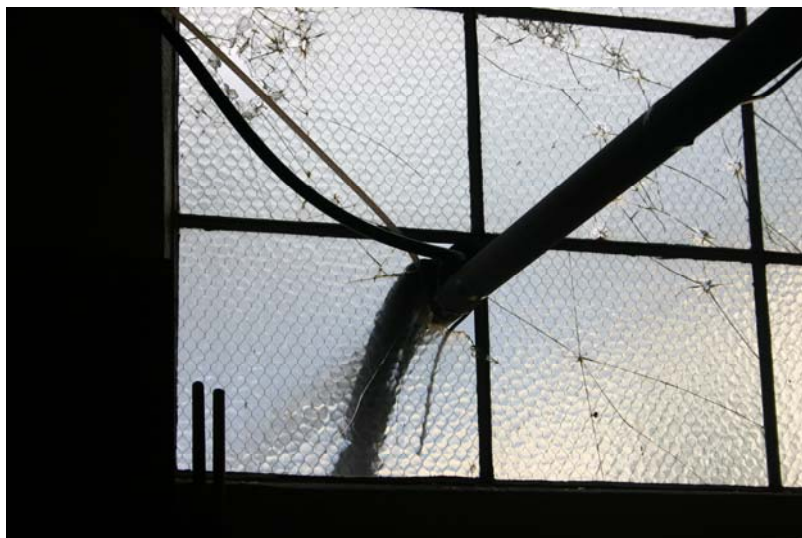
- 2.2 The pool heater gas supply piping is routed through a broken window of the mechanical room to its source outside of the building. This pipe should be re-routed through an appropriate wall penetration.

Gas Pipe Through Broken Window

(Estimated Cost \$6,500.00)

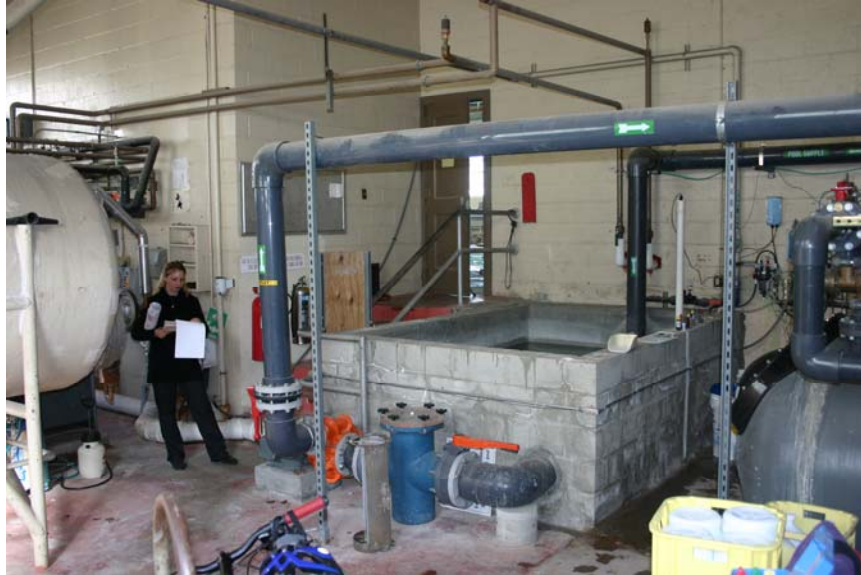
Existing Surge Pit Leaking

- 2.3 A water proof finish should be added to the interior of the surge pit to stop the water leaks. The following estimate is to apply two coats of Thoro-seal to the interior finish of the surge pit.

(Estimated Cost \$8,000.00)

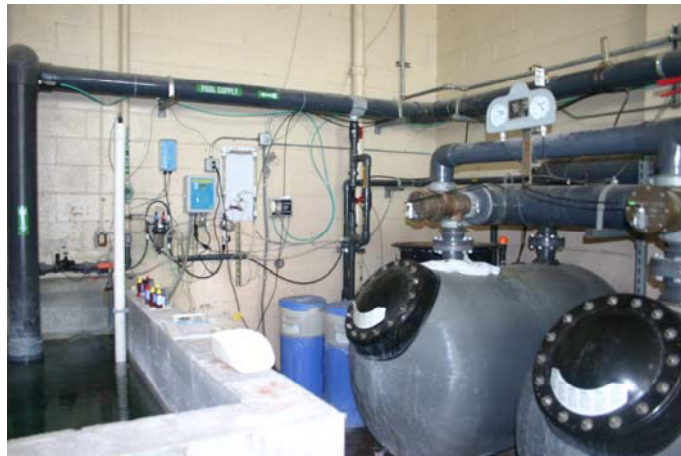
- 2.4 The existing swimming pool chemicals are stored in the pool mechanical room. The amount of chemicals currently stored in this space exceeds the fire code maximum exempt amount. For this volume of chemicals in the room this space would need to be an "H" hazardous occupancy. This space is not rated for this. In addition the chemicals in the mechanical room can have a negative impact on the mechanical equipment including boilers and such. Adjacent to this room is an outdoor storage area. A new chemical room could be created in this space to move the chlorine system.

Existing Chemical Feed Equipment

(Estimated Cost \$60,000.00)

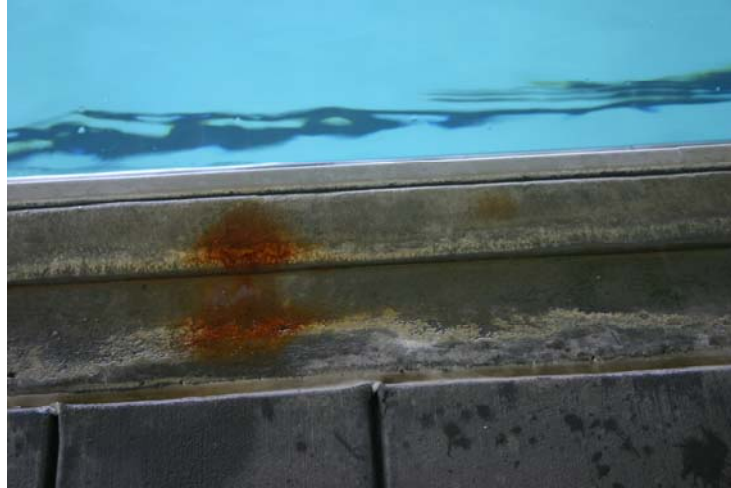
- 2.5 The existing swimming pool stainless steel gutter is corroding and showing signs of failure. This gutter can be an on-going maintenance problem as it continues to degrade causing water quality problems and perhaps safety concerns for the pool. The following estimate is to remove and replace the gutter with a traditional concrete and tile gutter. This estimate assumes that the pool deck and pool finish are replaced at the same time under a separate estimate.

Existing Stainless Steel Gutter

(Estimated Cost \$112,000.00)
