**GEOTECHNICAL ENGINEERING
AND GEOLOGIC HAZARDS STUDY**

Albany High School
Aquatic Center
Portland Avenue and Pomona Avenue
Albany, California

GEOSPHERE CONSULTANTS INC
2001 Crow Canyon Road, Suite 100
San Ramon, California 94583
Geosphere Project No. 91-02320-PWA & PWB

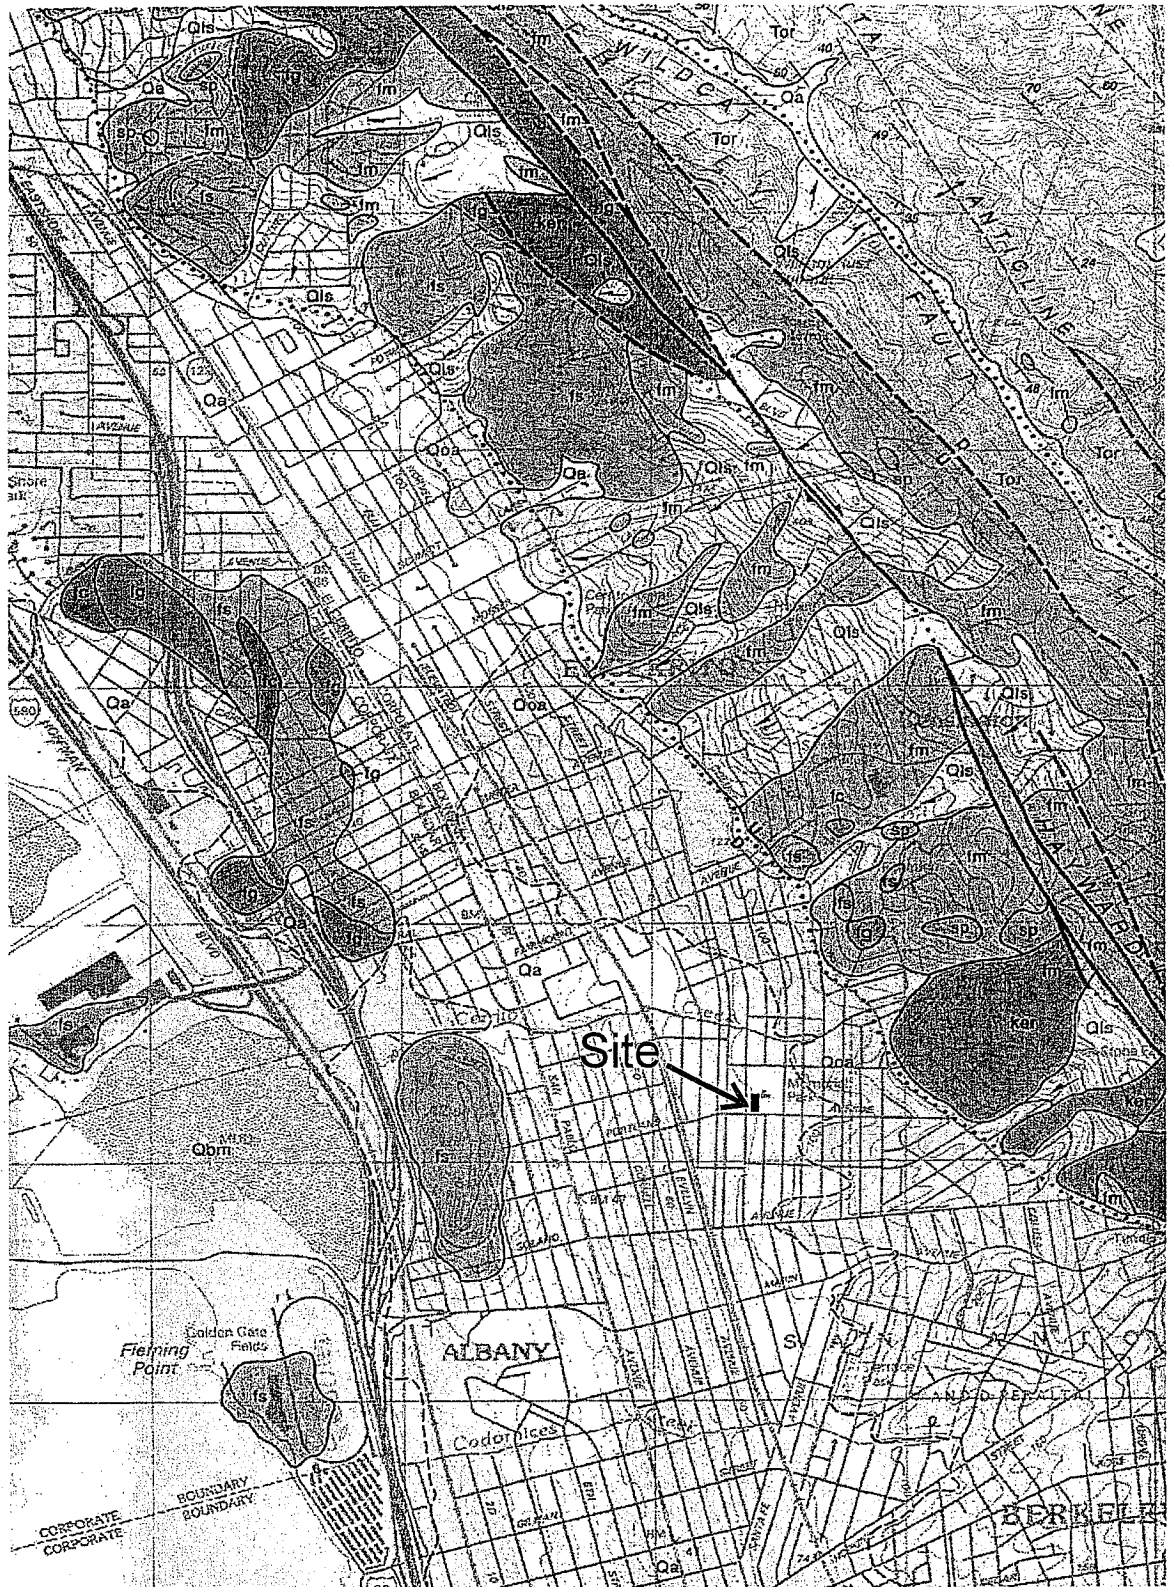
Figure 9

Source: Santa Barbara Museum of Natural History - Dibblee Geology Center, Geologic Map of the Richmond Quadrangle, Dibblee 2005.

Regional Geologic
Map
